DOT/FAA/AM-08/4  
Office of Aerospace Medicine  
Washington, DC 20591

# **Field Evaluation of Whole Airliner Decontamination Technologies – Wide-Body Aircraft With Dual-Use Application for Railcars**

Final Report

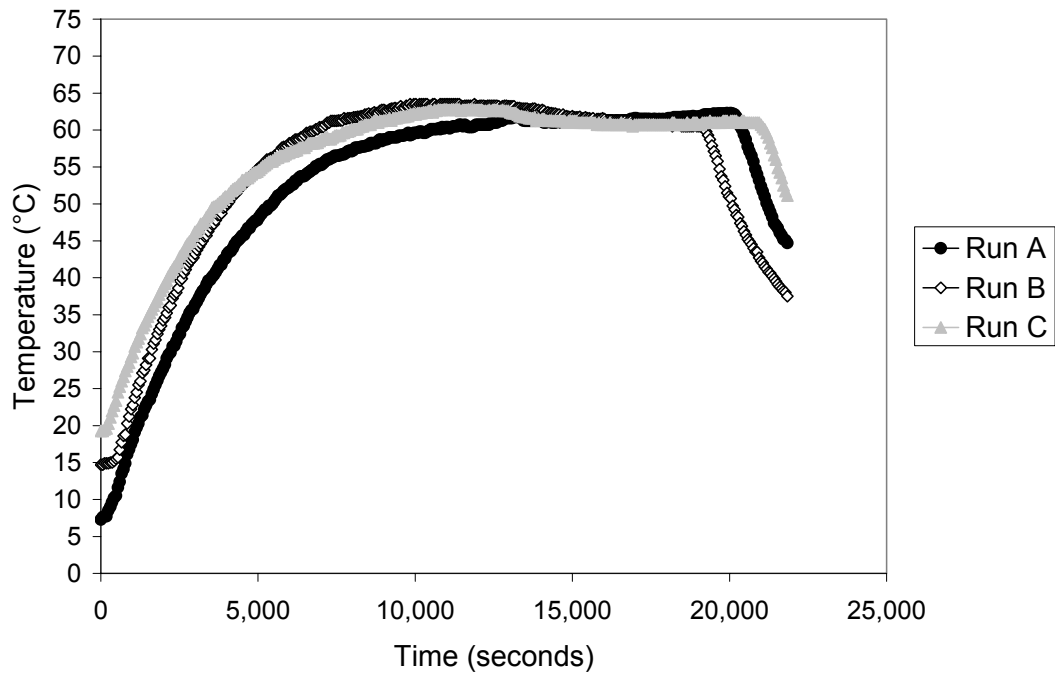
**Figure 1.** Profile from an armrest towards the rear of the cabin

It proved possible to heat the majority of the 747 cabin to close to 60°C and hold fairly near to this temperature for an extended period with the use of two thermal decontamination units (Figure 1). However, in some cases regions, it was not possible to hold at 60°C for 2 hours, as stipulated in the protocol (Figure 2). Surface temperatures in other locations (e.g. adjacent to the inlet) were found to exceed 65°C, with a maximum temperature of 71°C being observed where the incoming air stream impinged on the cabin (Figure 3). The two thermal decontamination units appeared to be well matched to the thermal mass of the 747, whereas a single unit had a rather larger heating capability than that required for a DC-9.

Cabin temperature on multiple cabin surfaces exceeded the desired 60°C. This was due to one of the two units having to be operated at 65°C and the second at 85°C, due to on-site power limitations. It must be noted that the present trials were conducted on a very tight schedule and budget. It is likely that given a longer lead time, more proving runs, and additional resources, the temperature control issues can be addressed.

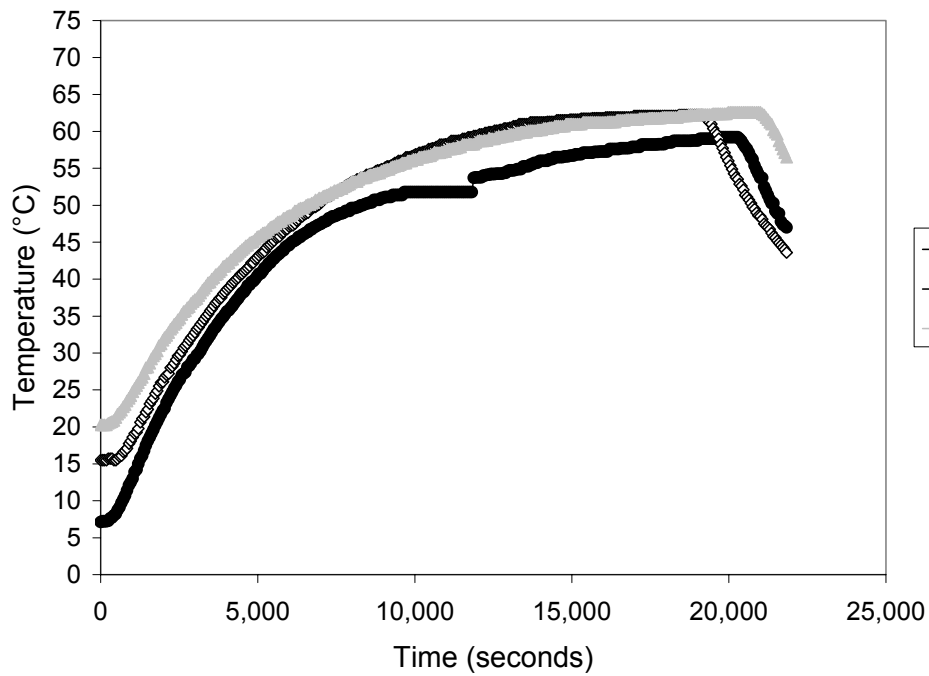
**Figure 2.** Profile from an armrest towards the front of the cabin

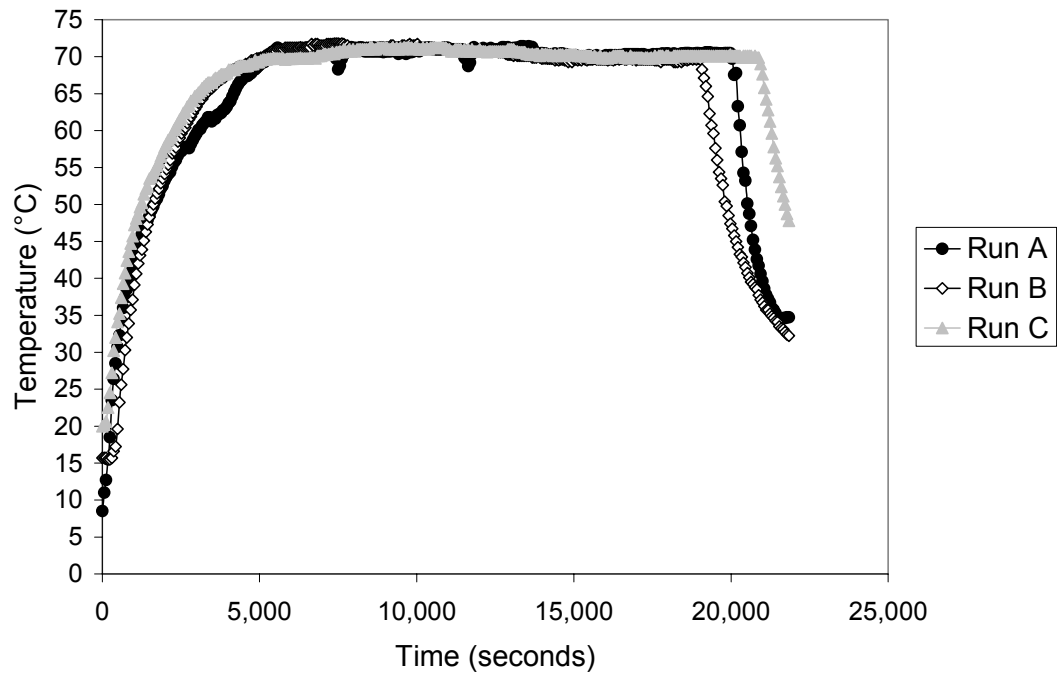
**Figure 3.** Profile from an overhead area adjacent to inlet

Most of the cabin was efficiently heated, without resort to an air distribution system within the cabin. However, one location, adjacent to one of the cabin service areas (galleys and lavatories), was found to have insufficient airflow, so an extension trunk was used to deliver air to this location (Thomas, 2007). It is possible that, with further optimization of the air delivery system, the extension trunk could be eliminated.

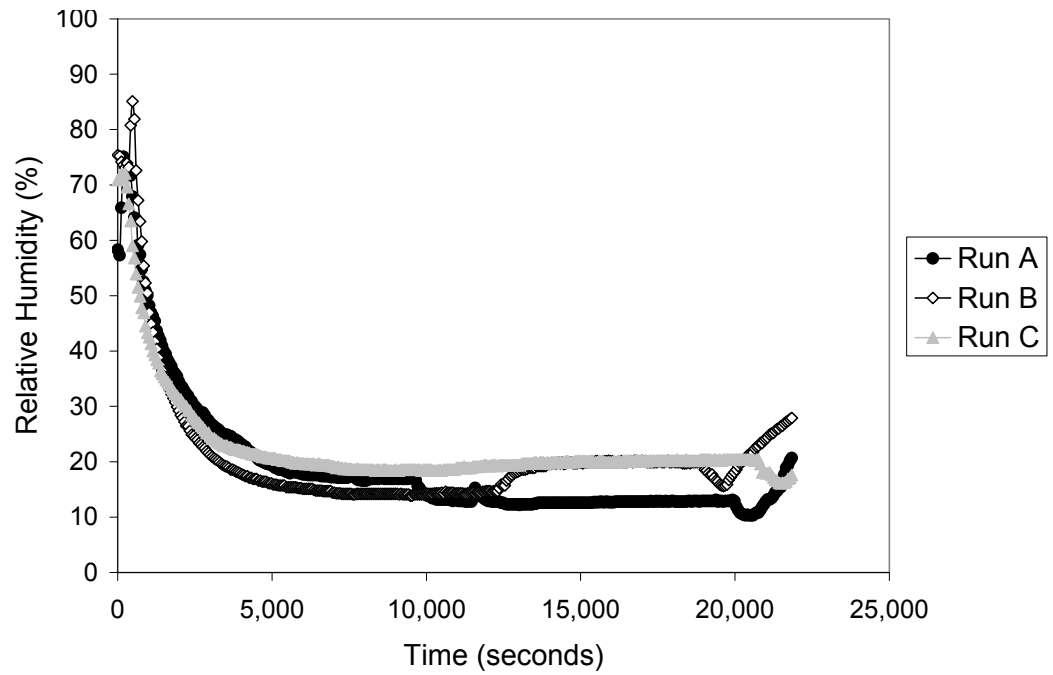
**Figure 4.** Relative humidity profile from the rear of the cabin

Using the 100 kW steam generator, it was not found possible to bring the cabin RH to above 20% (Figures 4 and 5).

Failure to reach a humidity of  $\geq 30\%$  RH for rapid antiviral efficacy (Rudnick et al., 2006) was disappointing. However, this does not appear to be a fundamental problem with the system but a matter of exceeding the capacity of the existing steam generator to humidify a wide-body aircraft. This is an issue that can be addressed easily in the future.

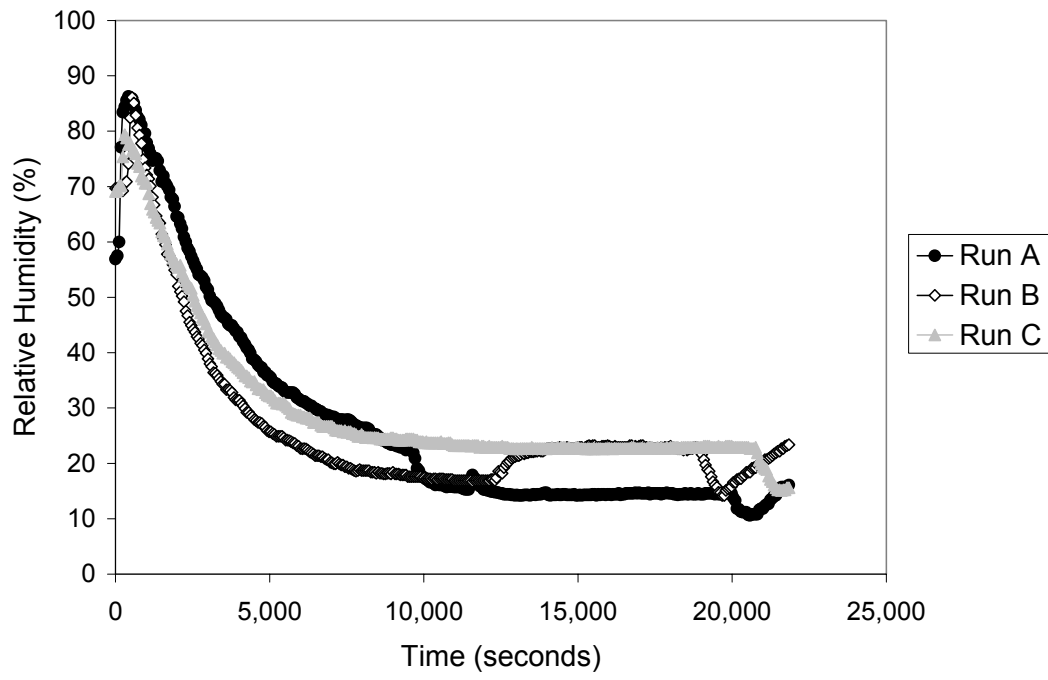
**Figure 5.** Relative humidity profile from the front of the cabin
